Roof renovation - listed building experiences

The Mansion House at Greys Court, near Henley on Thames, is a Grade I listed building owned by the National Trust. The roof of the principal wing of the building has been dated as from the 16th century. Here Richard Oxley reports on how the roofing works were undertaken in an environmentally sensitive way in 2006, to improve the thermal performance of the roof, and to bring an under used attic space back into use as a staff/custodian flat.

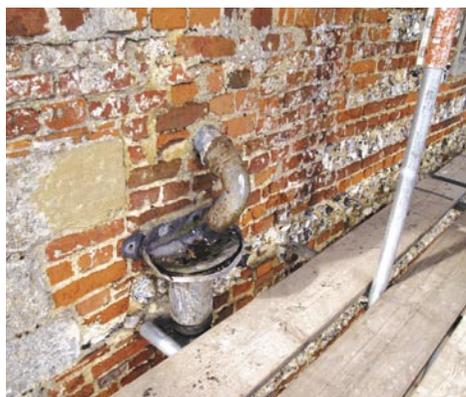
The five yearly inspection report identified the poor and deteriorating condition of the roof coverings and the ongoing and long-standing problems of water penetration and associated timber decay below the parapet gutters. The problems of water penetration were becoming more frequent, as a result of heavy deluges of rainfall overloading the concealed parapet gutters and their

Photo 1: detail of the outlet to one of the parapet gutters, the narrow pipe is prone to overloading and associated water penetration.

outlets, which were narrow pipes that could not cope with heavy and prolonged rainfall (photo 1). This situation was exacerbated by the poor detailing and condition of the leadwork in the parapet gutters.

Once the level of the parapet gutters was determined the hopperheads had to be refitted. The historic lead hopper was repaired and retained (photo 12) and provided with a new detail that improves the capacity and reduces the risk of overloading and associated problems of water penetration from incapacity in rain storms. The size of the outlets was also increased (compare photo 12 with photo 1). This addressed a principal cause of a problem to the building and provided an improved level of future proofing. Insulating dormers was also a challenge. Luckily the Mansion House does not have highly visible dormers, so making improvements to these features does not affect their appearance; the depth of the cheeks and roof have to be increased – and where they sit on flat roofs that are to be insulated the sill has to be adjusted to reflect this change

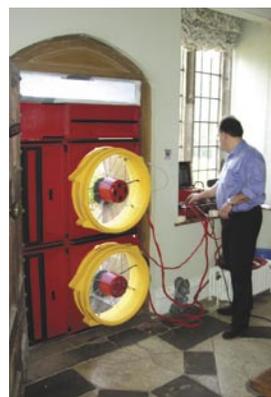
Photo 2: here the blower changes the air pressure in the building so that air leaks can be identified.

In keeping with the strong conservation ethos at the National Trust an environmental assessment, including an air pressure test (photo 2), was carried out. The air pressure test allowed the areas where excessive air infiltration, and therefore heat loss, was taking place to be identified.

It was calculated that approximately 30% of the heat from the building was being lost through the roof. This was physically illustrated by the amount of air movement experienced during the air test, with the greatest amount of movement experienced at the top of the second floor/attic level stairs.

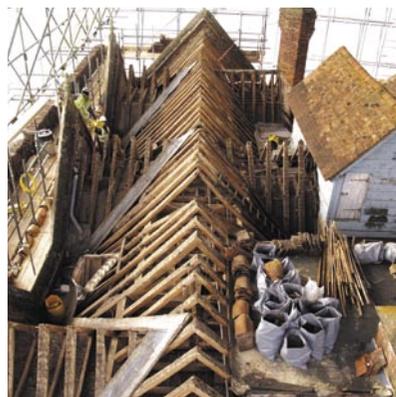
Photo 3: the complex oak roof frame was exposed on the removal of the roof coverings.

The roof is complex (photo 3), with the two principal ranges containing the attic flat comprising pitched roofs, with both horizontal and sloping ceilings and vertical partition walls to eaves voids.

As with many older buildings once works commenced, and the roof coverings were stripped, the true constructional detailing and condition of a complex roof structure was revealed (photo 3). The oak roof timbers located below parapet gutters and in contact with gable and parapet walls were in a poor condition, having suffered from serious decay (photo 4). The remaining timbers were found to be in a very good condition, with little repair being necessary to these timbers, albeit that they are around 500 years old.

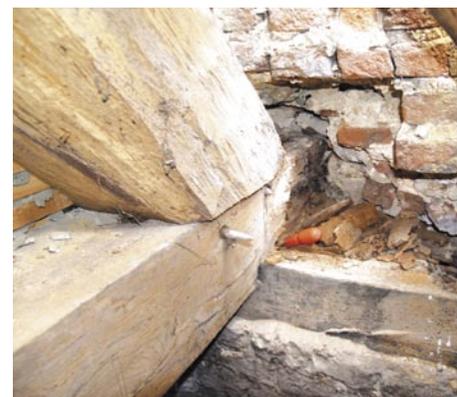
Photo 4: example of typical decay found below the parapet gutters. The end of the beam and the wallplate have suffered from extensive decay where they have been in contact with the damp masonry.

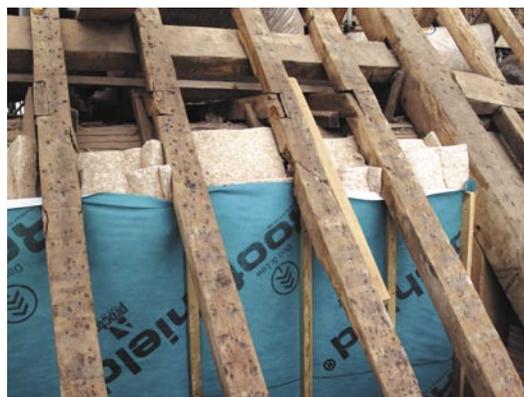
Photo 6: the insulation to the vertical stud partition walls of the attic room.

One of the most difficult areas to renovate was the vertical stud partitions to the eaves of the attic rooms (photo 6). The working area was severely restricted and the construction of the stud walls highly individual, with timbers of varied sizes at irregular spacing.

The solution was developed with the input of the contractor; to ensure that the method devised would be effective and practicable. The method devised to insulate the stud partition walls was applying cotton hemp insulation, held in place with a vapour permeable roofing membrane, which also improved air tightness, and battens fixed to the vertical studs.

In this case it was found that if the cotton hemp insulation was not held tightly in place with the roofing felt there would be a risk of slumping of the insulation over time. To reduce this risk the contractor was asked to achieve a full and tight insulation behind the felt, very much like a punch bag (photo 6). If the membrane was tight like a drum with no insulation in contact, or was soft like a pillow the risk of slumping was deemed too great. This set a simple understandable method by which the standard of work could be measured on site.

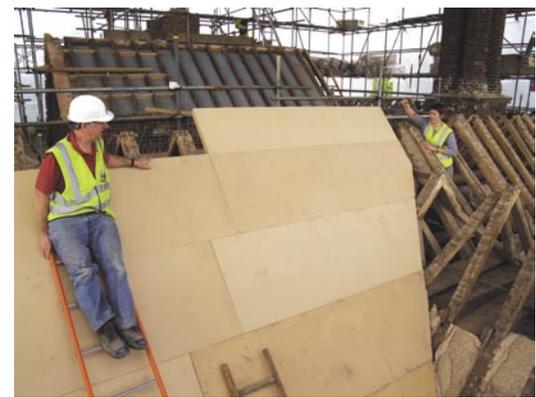
Photo 7: vertical and tongue and grooved wood fibreboard was installed over the existing rafters.

The method that was considered to be the most effective means of improving the performance of the roof was to create a 'warm roof' with 50mm thick wood fibreboard (photo 7), over the rafters and the parapet gutters, and, in this case, cotton hemp insulation above the sloping and horizontal ceilings. To maximise the air tightness of the warm roof system a vapour permeable roofing felt was specified to be placed directly over the wood fibreboard. This was largely to overcome

Once the sloping ceilings of the attic were insulated using hemp insulation, the external pitched slopes could be boarded using tongue and grooved wood fibreboard (photo 7). This was a difficult process; the roof was not straight or level and had several valleys. This meant that the boards, for each section of slope had to be close fitted then lifted off, re-scribed and cut and then refitted and secured to achieve an airtight fit.

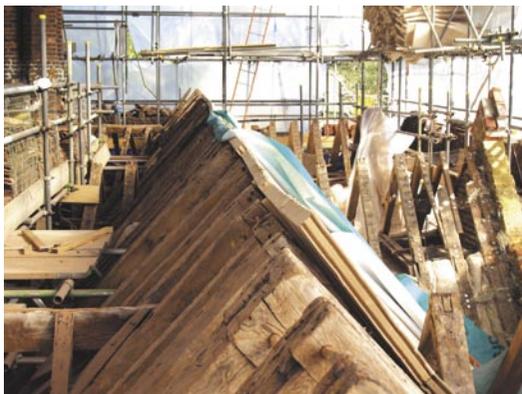
Photo 8: the uneven and irregular nature of an historic roof frame.

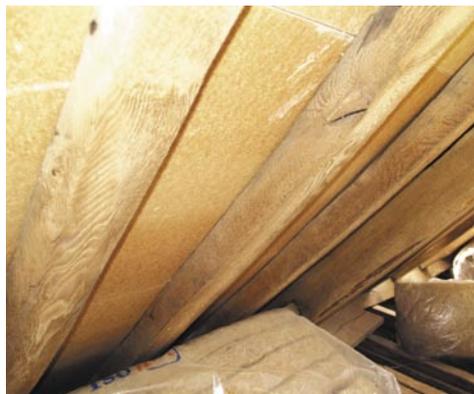
Photo 9: the wood fibreboards were pliable enough to follow the undulations of the roof.

An important part of the installation of the wood fibreboard was working closely with the supplier to ensure that suitable fixings were used that achieved a good grip and pulled the boards down without ripping through the boards (photo 9).

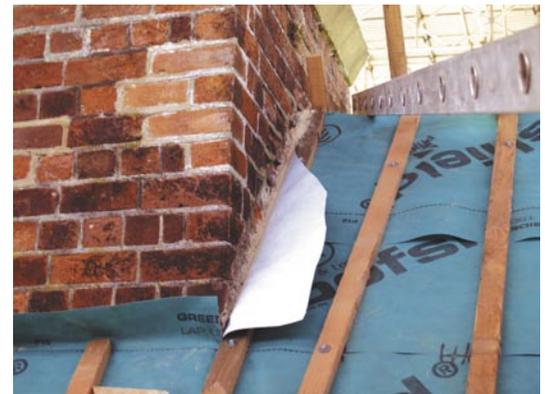
Photo 10: airtightness detailing was ensured, even through the breather membrane over the woodfibre boards.

Significant care and attention to detail was necessary to maximise the airtightness of the building. The wood fibreboard was physically separated from potentially damp masonry, such as chimney stacks and gable walls, to reduce the risk of future problems caused by the boards being in prolonged contact with damp walls, as this could result in the decomposition and/or expansion of the wood fibreboard. It was also important, at this stage, for all gaps to be filled whilst access was available (photo 10).

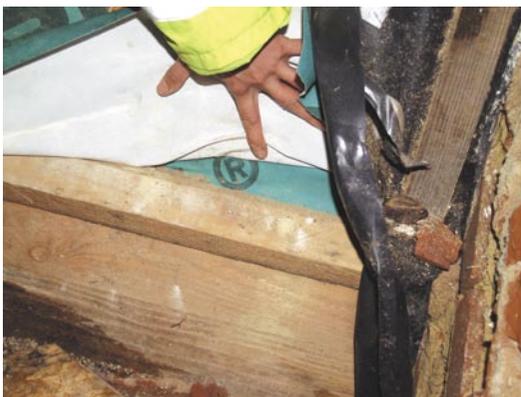
The use of wood fibreboard insulation over the rafters resulted in the raising of the roof line by the depth of the boards and counter battens (75mm). In general this did not cause too many problems, as the roofs were concealed by the gable and parapet walls. Also, the provision of wood fibreboard to the slopes and in the parapet gutters meant that the location of the parapet gutters and their outlets changed; they moved higher up the parapet wall.

Photo 11: the thickness of the roof was raised by the use of the woodfibre boards. This is the eaves detail in the parapet gutter area.

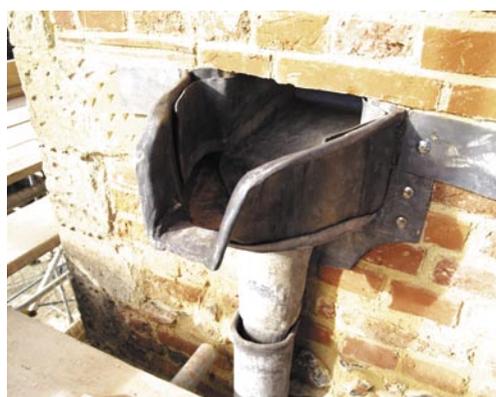
Photo 12: the rainwater outlets were restored and changed to hoppers.

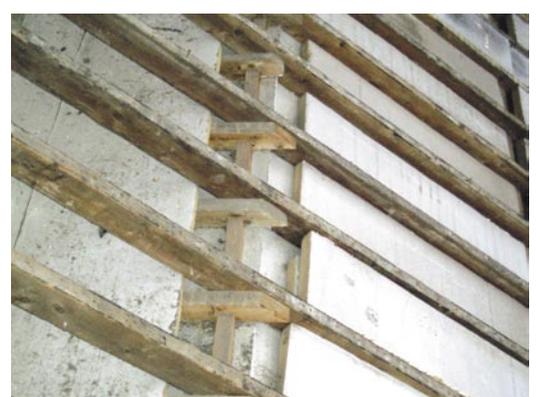
The amount of insulation in the building before renovation took place was minimal. One wing had been provided with foil-backed foam insulation. These were not well laid, with numerous gaps and open joints. Under current assessment methods this would provide a favourable rating, irrespective that the effectiveness of

the insulation would be minimal (photo13).

Photo 13: the original insulation prior to renovation was badly fitted with gaps and shortfalls.

The opportunity was taken to provide well detailed insulation that would significantly improve the thermal performance of this part of the building. The foil-backed foam boards/batts were re-used, being well detailed and double-lapped, behind foil backed plasterboard to the partition walls to this part of the building, where vapour permeability was not important, thus maximising the re-use of materials and reducing waste.
