Surveying Historic Timber-Framed Buildings

The survey, identification of defects and specification of remedial work in timber-framed buildings is a specialised area and a trap for the unwary. Richard Oxley provides some initial guidance on this important subject.

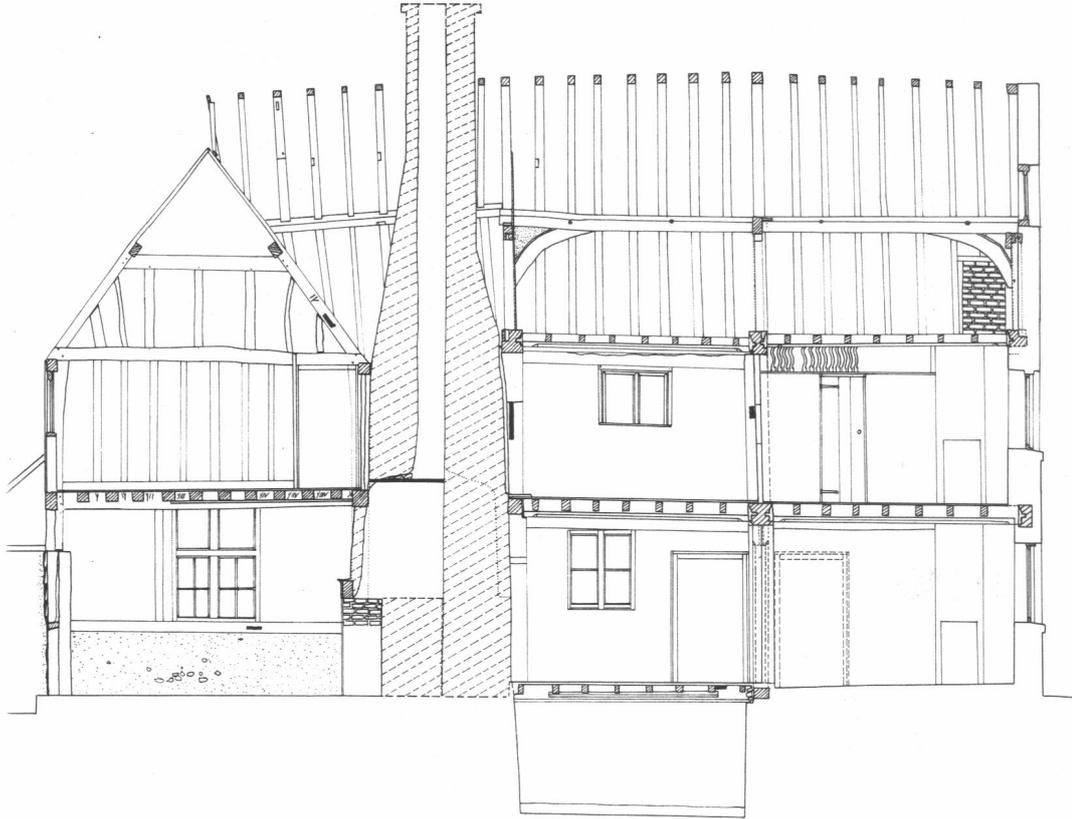
Figure 1: Brockley Hill Farm, Stanmore, Middlesex. Drawing by Mike Dunn, Beams, Hertford

The physical survey of timber-framed buildings is greatly assisted if a measured survey is available (*fig 1*). The availability of such information makes it easier for the surveyor to understand the building, and to identify alterations and any timbers that are missing. However detailed information of this nature will not normally be available and the surveyor will have to collate as much information as possible on site. This is usually best achieved by sketching and annotating the timber frame (*fig 2*).

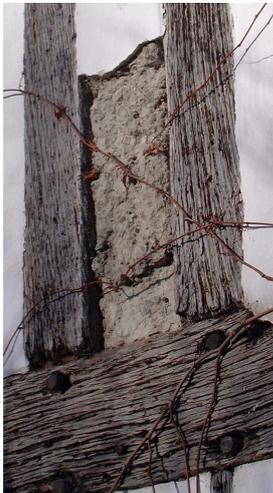
Surviving earth finish – infill. Every effort needs to be made for surviving historic finishes to be retained within any programme of repair

Sensitive historic fabric, such as wattle and daub, earth and lime plasters and wall paintings, are all at risk where physical repair is required. Unfortunately many historic buildings have lost their historic finishes during programmes of repair. It is therefore essential that a greater emphasis is placed upon retaining these finishes and that stripping back to the skeleton is avoided at all costs.
